Ham Tips

Number 26

Rebuilding a Barker & Williamson BWD-90 Folded Dipole HF Antenna

Eric J. Grabowski, KH6CQ

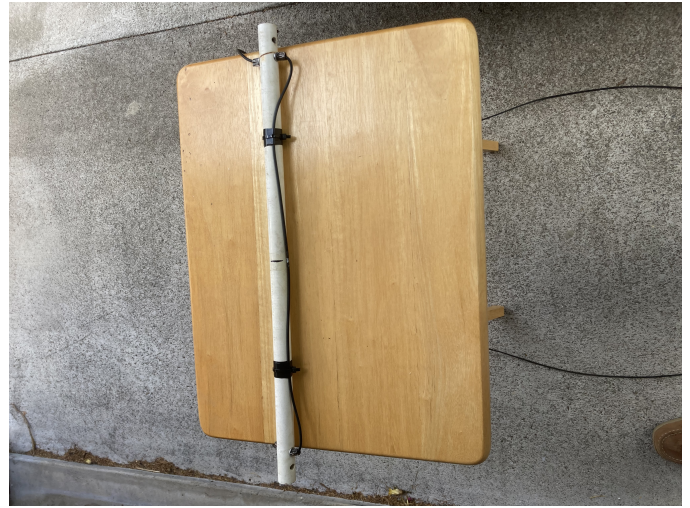
Figure 2 — It is important to align the center of the wire with the center of the end spreader before securing it with electrical tape, washers, and ferrules.

I started by securing the antenna wire to one of the end spreaders as shown in Figure 2. Using a black Sharpie® I marked the center of the spreader and using a silver Sharpie® I marked the center of the antenna wire. Then I temporarily attached them together with masking tape while I applied electrical tape and UV resistant Ty-Rap® cable ties. It's important to get the alignment correct; otherwise, the top and bottom wires will not end up being the same length.

Next I slid a ferrule and a washer onto the antenna wire, pushed the wire through the hole in the spreader, and crimped the ferrule. Then I slid another washer and ferrule onto the antenna wire, pushed it against the other side of the spreader, and crimped it. When finished, I repeated this procedure for the lower antenna wire.

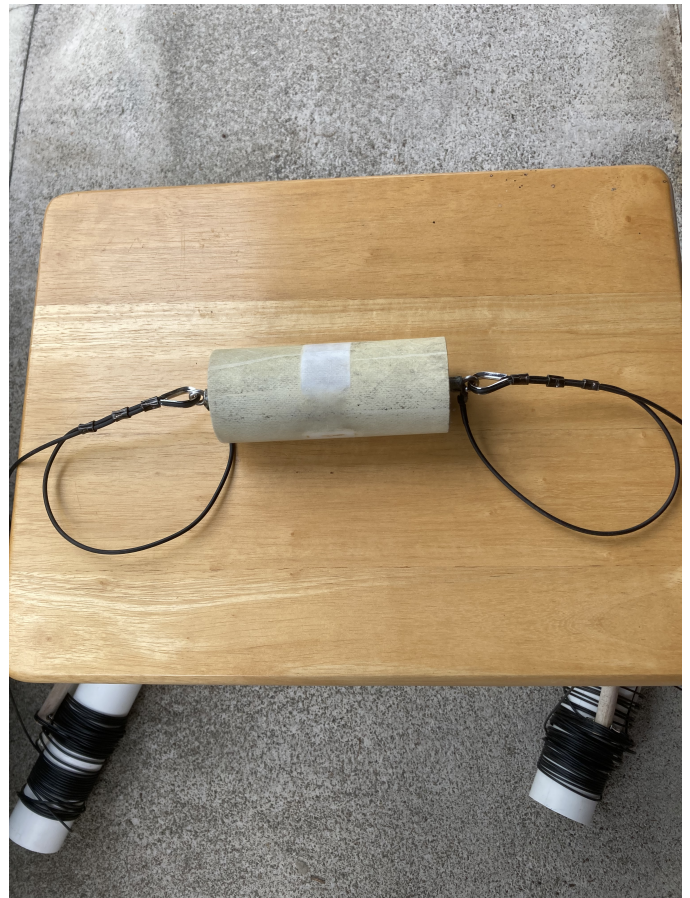
Figure 3 — Top wire attached to the balancing network with thimbles and ferrules. Each side of the antenna is rolled up onto 3-inch diameter plastic pipes for transport to the site.

The next step was to secure the antenna wires to the balancing network and the balun. To mitigate abrasion at the eye bolts, the wires were attached using 1/8-inch stainless steel thimbles (found at a local fishing supply store) secured with three ferrules leaving a 9-inch pigtail for the termination loops. See Figures 3 and 4.

The most convenient way to transport this antenna to its final destination, was to roll each side onto a length of plastic water pipe 3-inches in diameter about two feet long and then secure them with bungee cords as shown in Figure 3.

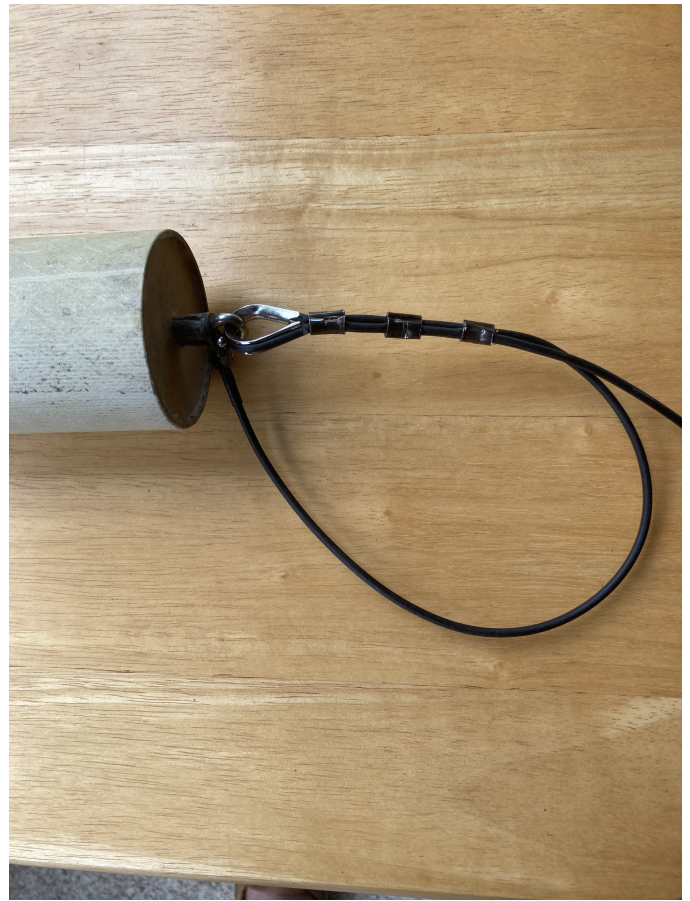
Figure 4 — Closeup of how the wire is connected to the balancing network. The balun was connected in the same way.

Finally 3/8-inch of insulation was removed from the end of each pigtail and tinned. Soldering these into the existing ring terminals on the balancing network and balun was the most difficult part of this project. Even though I used a 200-Watt soldering gun, it took longer than expected to heat the terminals sufficiently so they could be filled with solder and the pigtails inserted.
